To: File
From: Andy Hummel, P.E.
CC: Ron Korman, Dan Hamlin
Date: 5/31/2013
Re: Raincheck Stormwater Training, attendees list

<p>City of Sparks 431 Prater Way Sparks, NV 89431</p>	<p>Maintenance Facility Stormwater Management Plan</p> <p>Main Yard on S. 21st Street</p>

find the specific audit findings that were identified as “program deficiencies or potential permit violations” in bold followed by SWPCC response noted in italics.

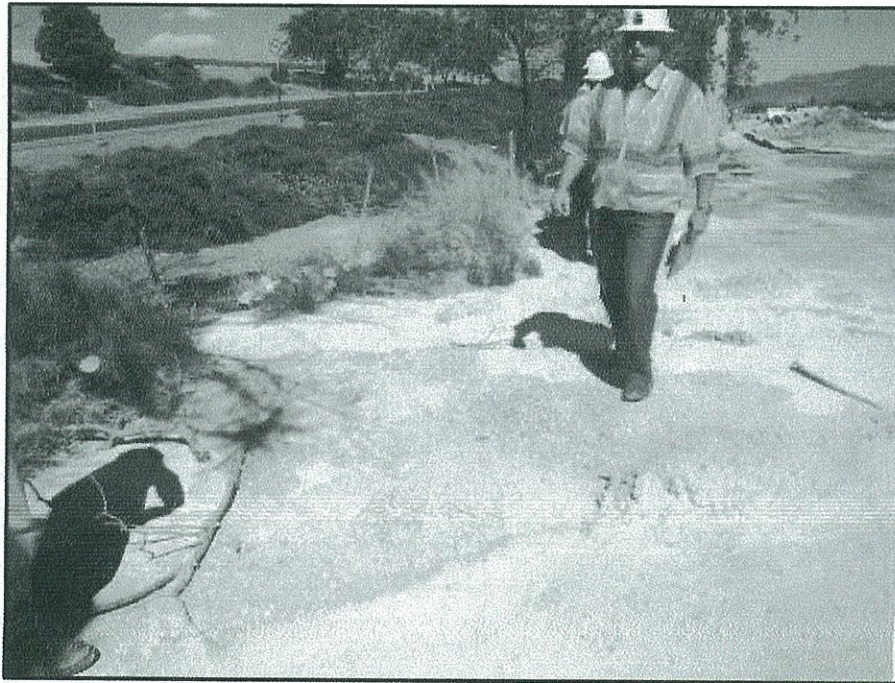
Photo 84 – Cemex Wash-Out Yard in Reno. This photo is taken along the northwest boundary of the Wash Out Yard. There were no controls along this portion of the Yard to prevent excess rainwater or process water from leaving the site.

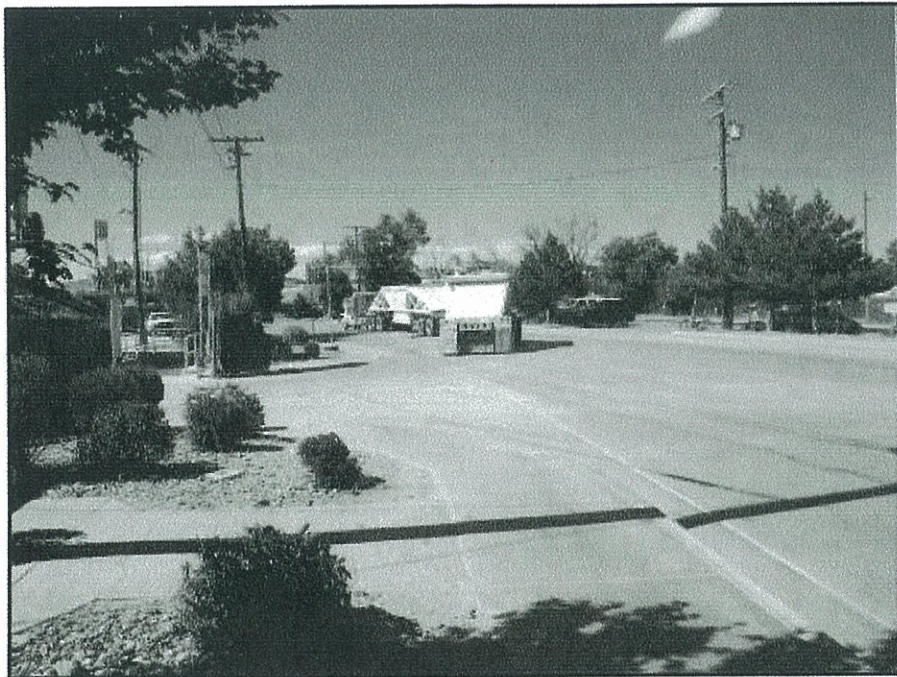
Photo 85 – View along Galletti Way looking north as an aggregate truck leaves the site. Note the track out from the facility to the public street. The facility sweeps the yard and street regularly.
